The collapse of the Cypress Viaduct during the Loma Prieta earthquake of October 17, 1989

Mohamed M. Eid
New Jersey Institute of Technology

The Collapse of the Cypress Viaduct During the Loma Prieta Earthquake of October 17, 1989

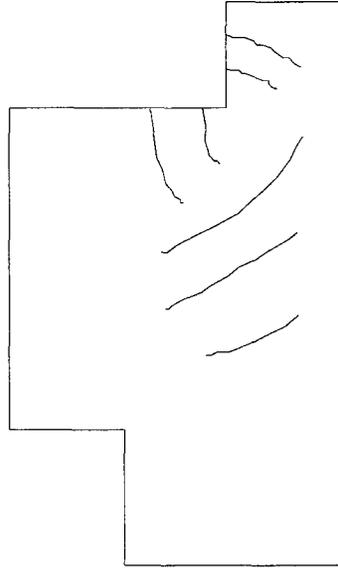
Figure 2.2 Lower Column-to-Girder Joint.

Static analyses: The Uniform Building Code (UBC, 1988) assumption of an inverted triangular distribution of the effective lateral load due to the earthquake was used to determine the forces at both decks. The force at the upper level is twice that at the lower level. Thus two-thirds of the total base shear is applied to the upper level bents and one third to the lower bent. These forces were used as input for static finite element analyses of bent type B1 and B2. Vertical loads were applied as a uniform acceleration of 1.06g (including gravity load), based on the peak vertical acceleration components at the seismic station previously mentioned. The contours of maximum principal tensile stress indicate that the column support pedestal for the upper columns in type 1 bents is highly stressed and that crack initiation will occur beneath the shear key with the crack pattern as shown in Figure 2.2.

Crack initiation in the concrete was assumed to occur at a tensile stress of 460 psi, based upon the ACI tensile strength formula (ACI, 1989) for a compressive strength of 6,000 psi.

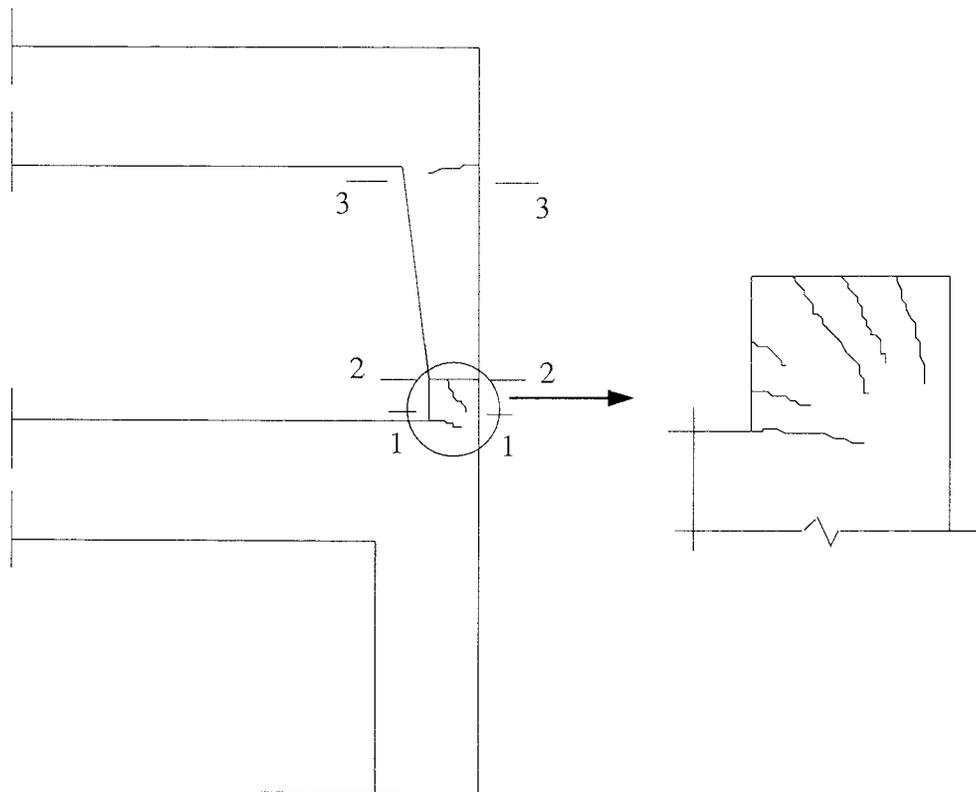
Figure 4.45 Damage to B1 Bents

The pedestals (the part of the upper columns below the shear keys) on both sides of the bent suffered shear failure at section 2-2 and extensive flexural cracking at section 1-1 (Figure 4.45). This enabled the gravity load of the upper story to push the pedestals down and away (laterally) from the bent causing the upper deck to fall down on top of the lower deck as shown in Figure 4.46. The collapse appeared to be perfectly vertical due to the fact that the lateral displacement of the upper deck was small. The extensive cracking at section 3-3 (both sides of the section) allowed rotation of the upper columns at that location, suggesting that the upper columns pushed the pedestals in an inclined direction away from the bent.
