The collapse of the Cypress Viaduct during the Loma Prieta earthquake of October 17, 1989

Mohamed M. Eid
New Jersey Institute of Technology

The Collapse of the Cypress Viaduct During the Loma Prieta Earthquake of October 17, 1989

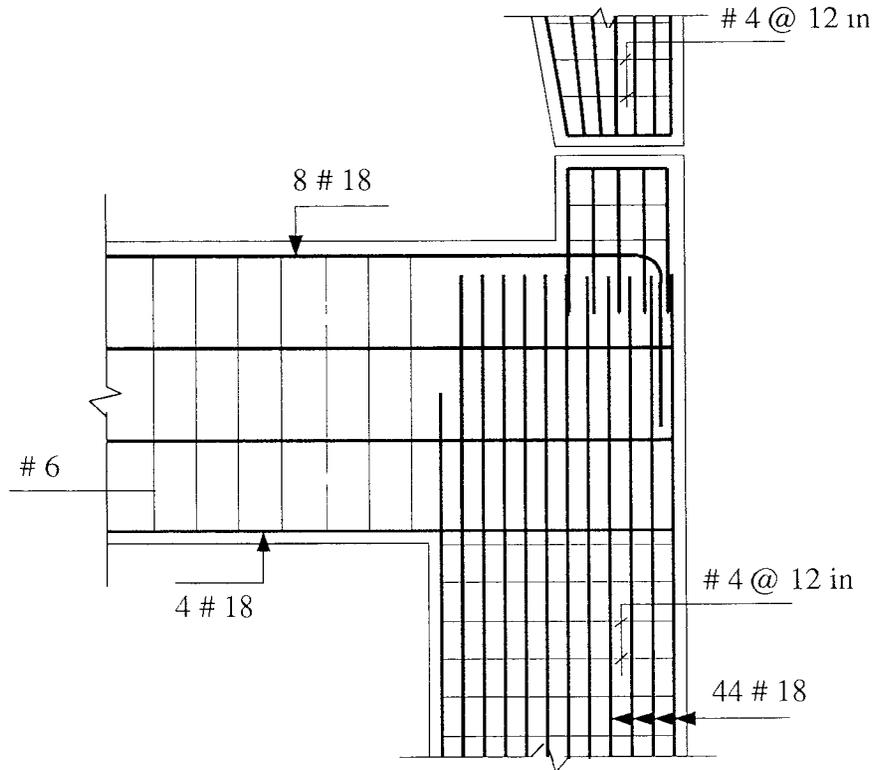
Figure 1.4 Lower Level Joint Detail of Type B1 Bent.

The lower girder-to-column joints on both sides of the B1 bents failed. The collapse seems to have initiated by the failure of the pedestal (the part of the upper column just below the shear key). The failure surface is basically coincident with the curved surface defined by the lower girder negative reinforcement that is bent down into the lower girder-to-column joint (see Figure 1.4).

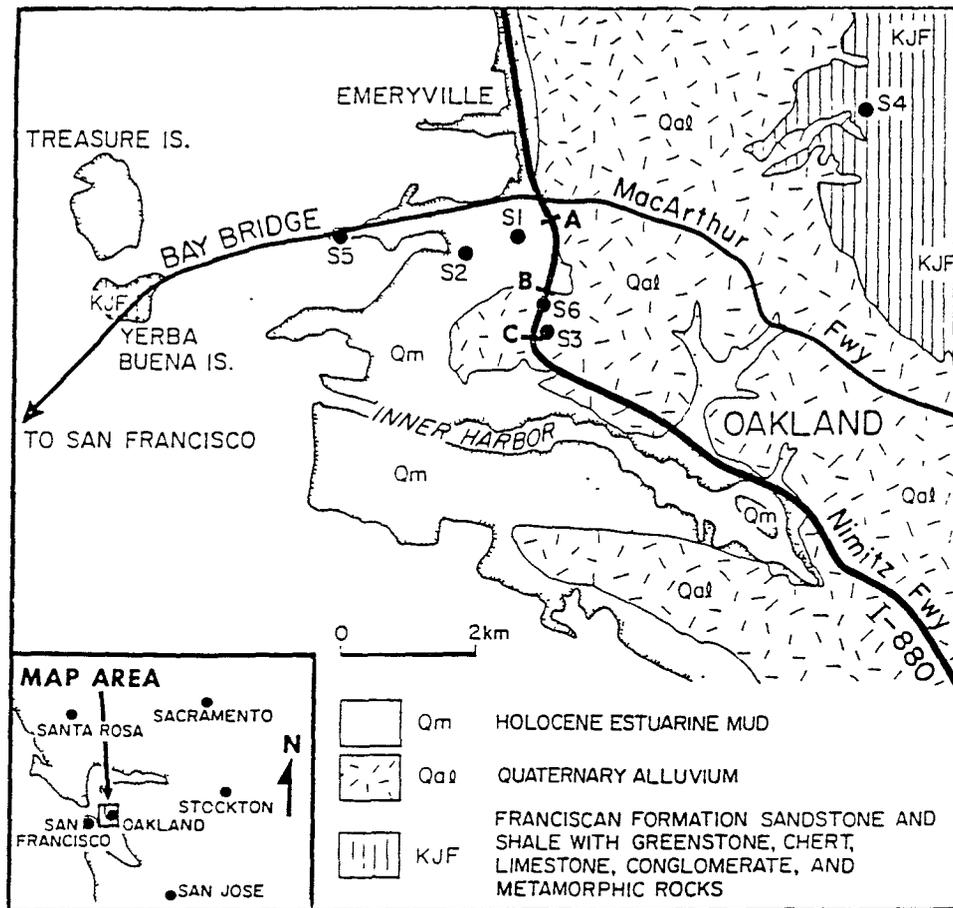
Figure 1.7 is a map of Oakland showing near-surface geology. Section AC indicates the extent of the effected portion of the Cypress Viaduct by the earthquake. AB indicates the segment that collapsed, and BC indicates the segment that was damaged but did not collapse.

would be less than section AB, and that explains why section BC was damaged while section AB collapsed.

Figure 1.7 Map of Oakland Showing Near-Surface Geology. AC Indicates the Extent of the Effected Portion of the Cypress Viaduct. AB Indicates the Segment that Collapsed; BC Indicates the Segment that Was Damaged But Did Not Collapse [3].

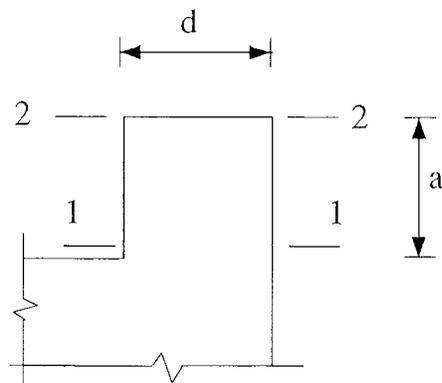
For the part of the upper columns below the shear keys, shown in Figure 3.5, the ratio $a/d < 1.0$. Therefore, it will be treated as a corbel according to ACI code. The failure modes of the corbel are:

Figure 3.5 Upper Column Just Below the Shear Key.

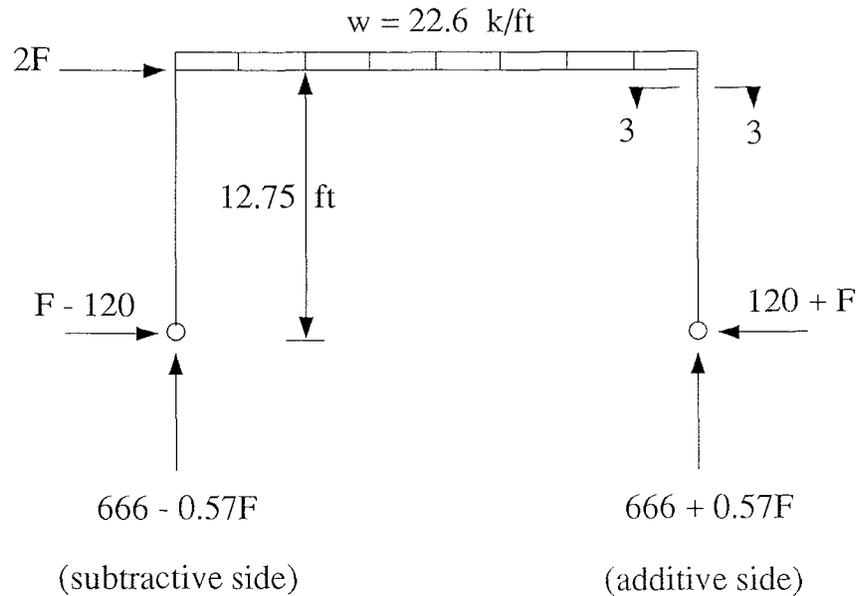
As seen in Figure 3.8, the critical bending moment and axial force are determined from the additive side.

Figure 3.8 Analysis at Section 3-3.

for section 1–1. This is despite the fact that the cross sectional area of section 3–3 is bigger and the steel reinforcement is higher (as seen in Figure 1.3). This is due to the fact that the bending moment at section 3–3 is higher than the bending moment at section 1–1 (see Equations 5.19 and 5.7).

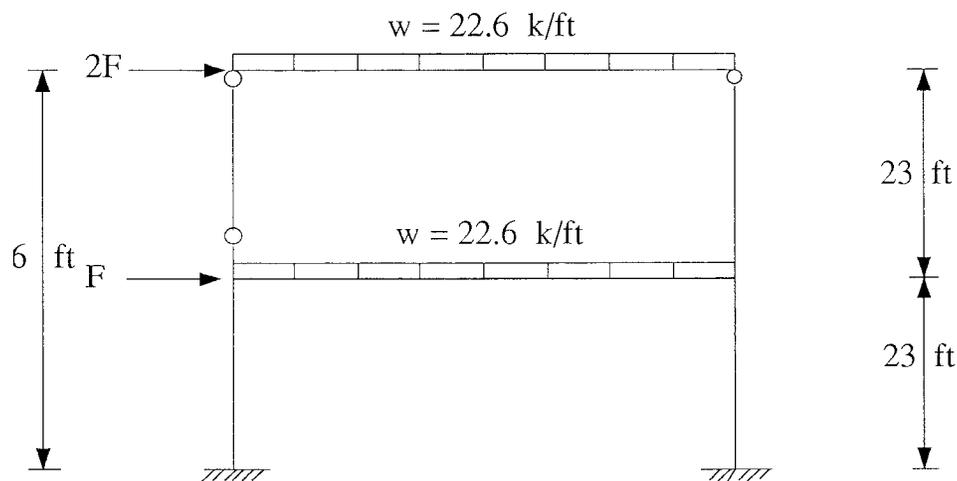
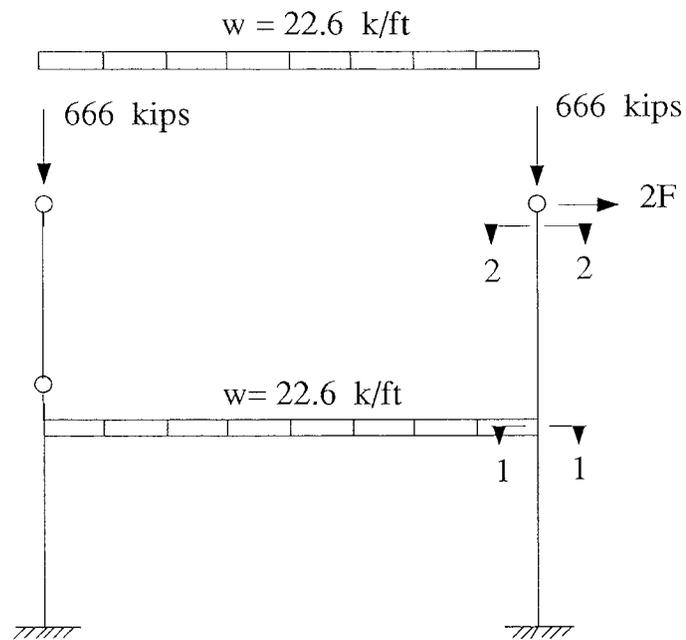
As shown in Figure 3.9, the lateral seismic force $2F$ at the upper girder is resisted entirely by the continuous column (with one hinge at the top). This is due to the fact that the two hinges in the upper west column of the bent allowed significant rotation as shown in Figures 1.14 and 1.15 (Chapter 1). The upper west column (with two hinges) structurally behaved as a truss member, resisting axial forces

only. Practically, the column resisted a portion of the horizontal shear force. Where some bents suffered shear cracking underneath the truss members. To be more conservative, that portion will be ignored.

Figure 3.9 Analysis of B2 Bents

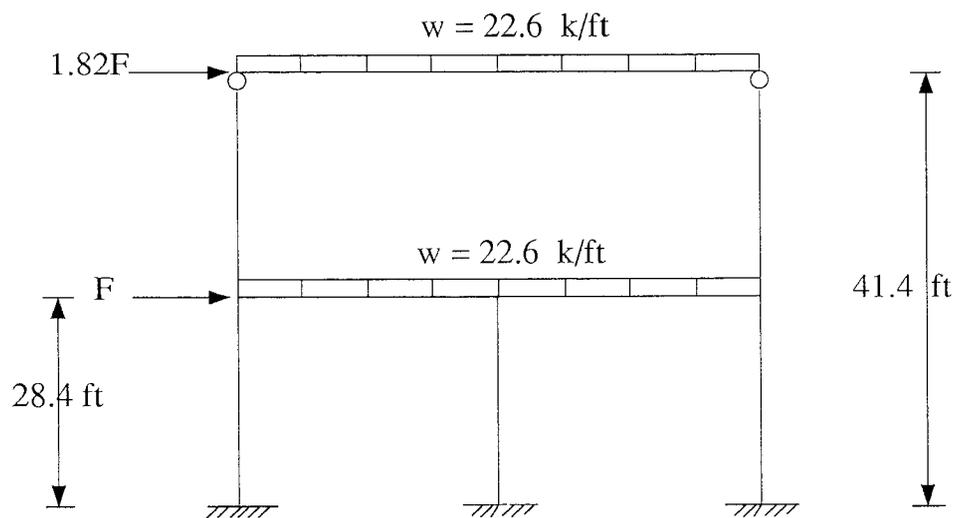
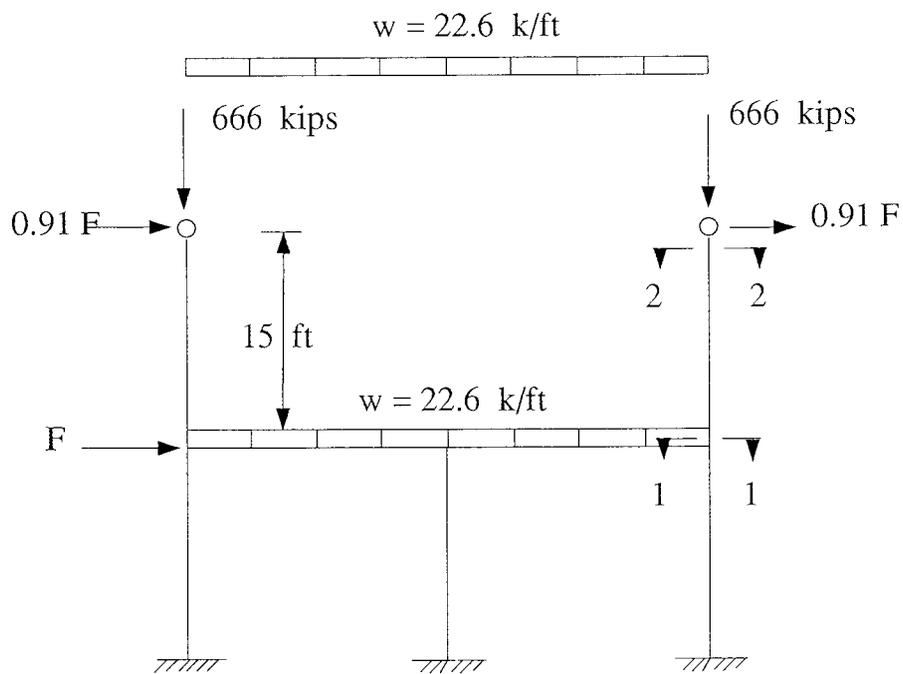
As seen in Figure 3.11, the lateral seismic force at the upper deck is resisted by both columns. The P-M interaction diagram of section 1-1 was calculated as shown in Figure 3.12 and used in analyses.

Figure 3.11 Analysis of B3 Bents.

As seen from Table 3.6 and 3.7, a flexural failure at section 1–1 would occur at upper girder force $(1.82F) = 727$ kips. Where shear cracking at section 2–2 would not cause the failure of the structure. Therefore, a base shear force = 1126 kips = $0.40W$ would cause the flexural collapse of B3 bents.

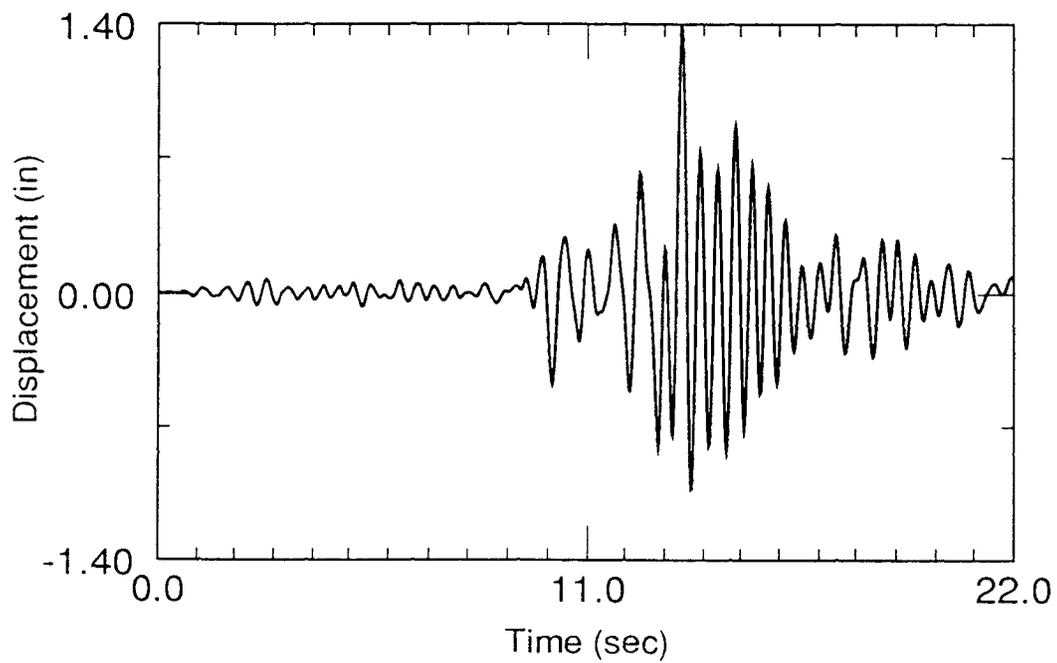
Figure 4.23 Lateral Displacement (Node 3)

The top level lateral displacements (node 3) are 1.39 in. (Figure 4.23) and 1.88 in. for bent heights of 46 ft and 54 ft, respectively. These are significantly higher than the top level displacements of 0.72 in. and 1.3 in. for the unretrofitted and the retrofitted structures (as mentioned before in Chapter 2, Section 2.1.2), which indicates that the structure had undergone large inelastic deformations in the upper story especially in columns just below the shear keys.

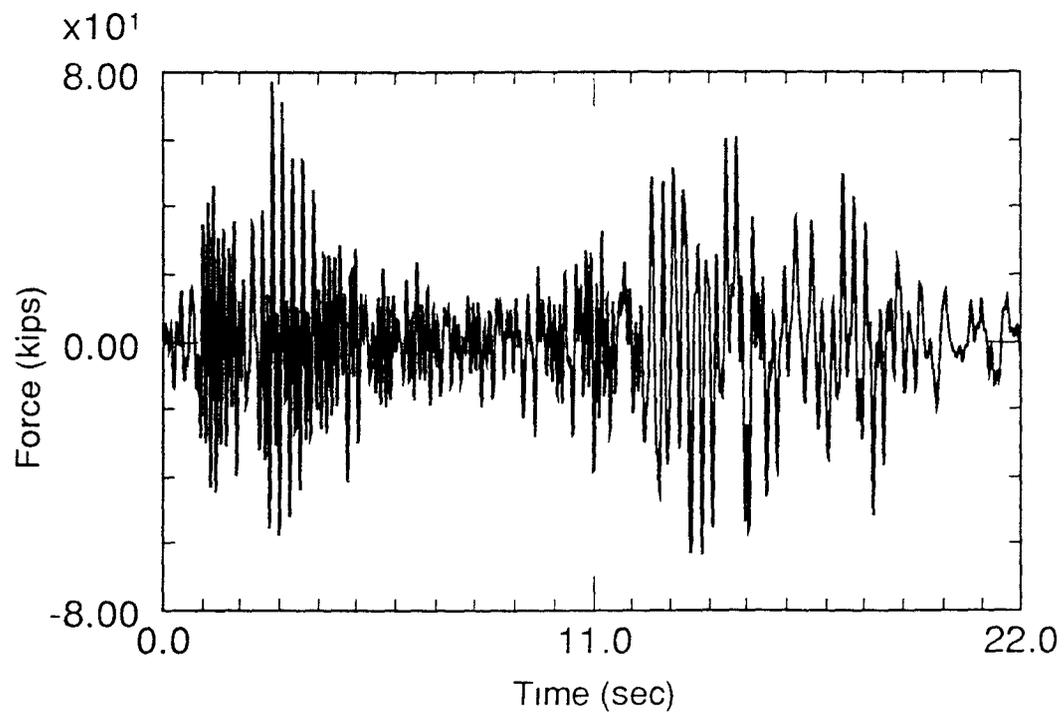
Figure 4.41 Seismic Axial Force (Node 1)

The maximum seismic axial tension force (635 kips), shown in Figure 4.41, did not exceed the vertical compressive force (708 kips) resisted by the upper column due to gravity loads, which shows that net force acting on the upper columns during the earthquake was compressive, implying that there was no effect on the shear strength of concrete at section 2–2 by the axial force (where tension forces reduce the shear strength).

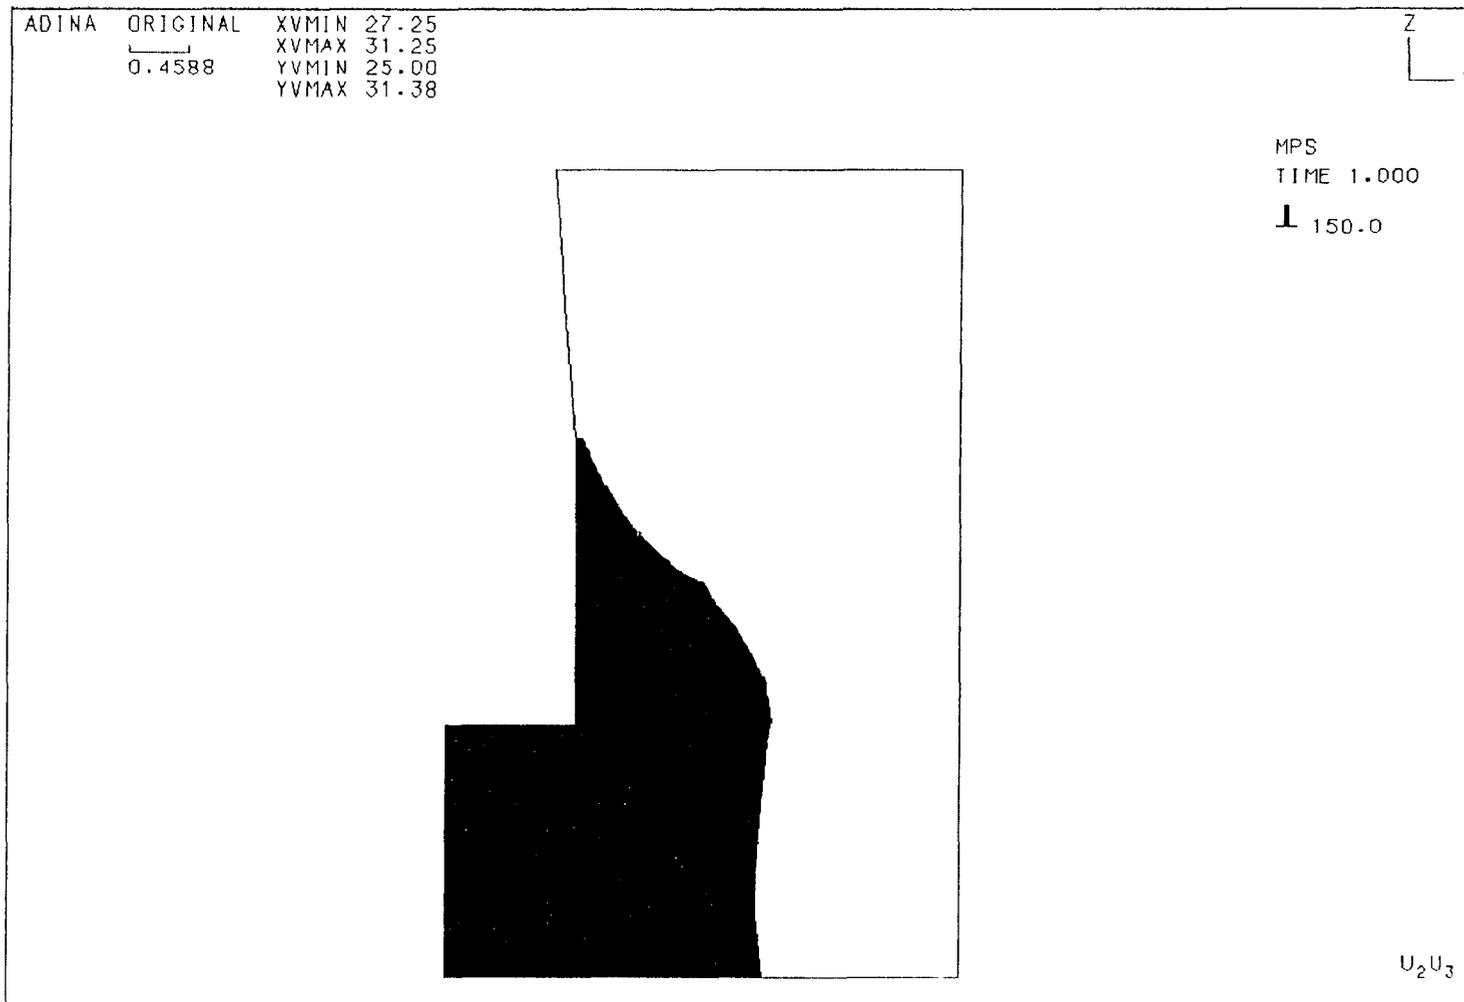
Figure 4.42 Tensile Stresses in Lower Girder-to-Column Joint

Figure 4.42 shows the distribution of the tensile stresses in the lower girder-to-column joint. Large portion of the column was subjected to tensile stresses far exceeded the tensile strength of concrete (83.7 k/ft^2). The previous stresses is expected to be reversed on the other side of the column when seismic forces are reversed due to cycling. Therefore, extensive flexural concrete cracking is expected to take place at the joint between the upper columns and the lower girder and diagonal shear cracking at the discontinuous surface of the upper columns. Due to cracking, that portion of the column became a point of weakness in the structure.

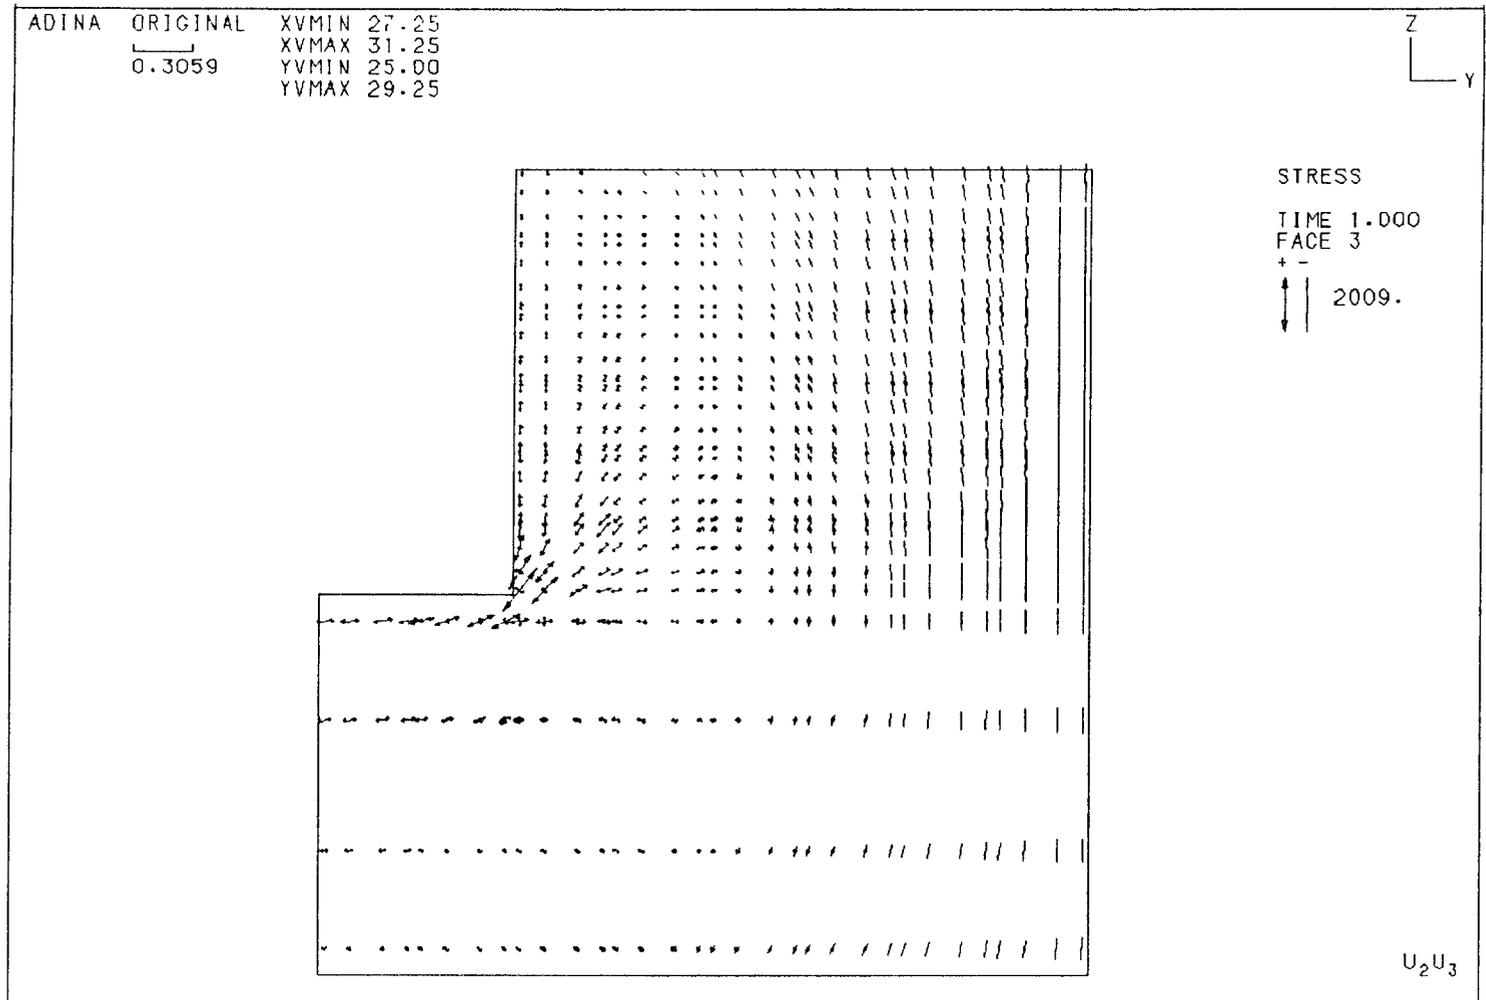
Figure 4.43 Stress Vectors in the Upper Column (Below the Shear Key)

Figure 4.43 shows the stress vectors in the column indicating high tensile stress concentration at the inner side of the joint.

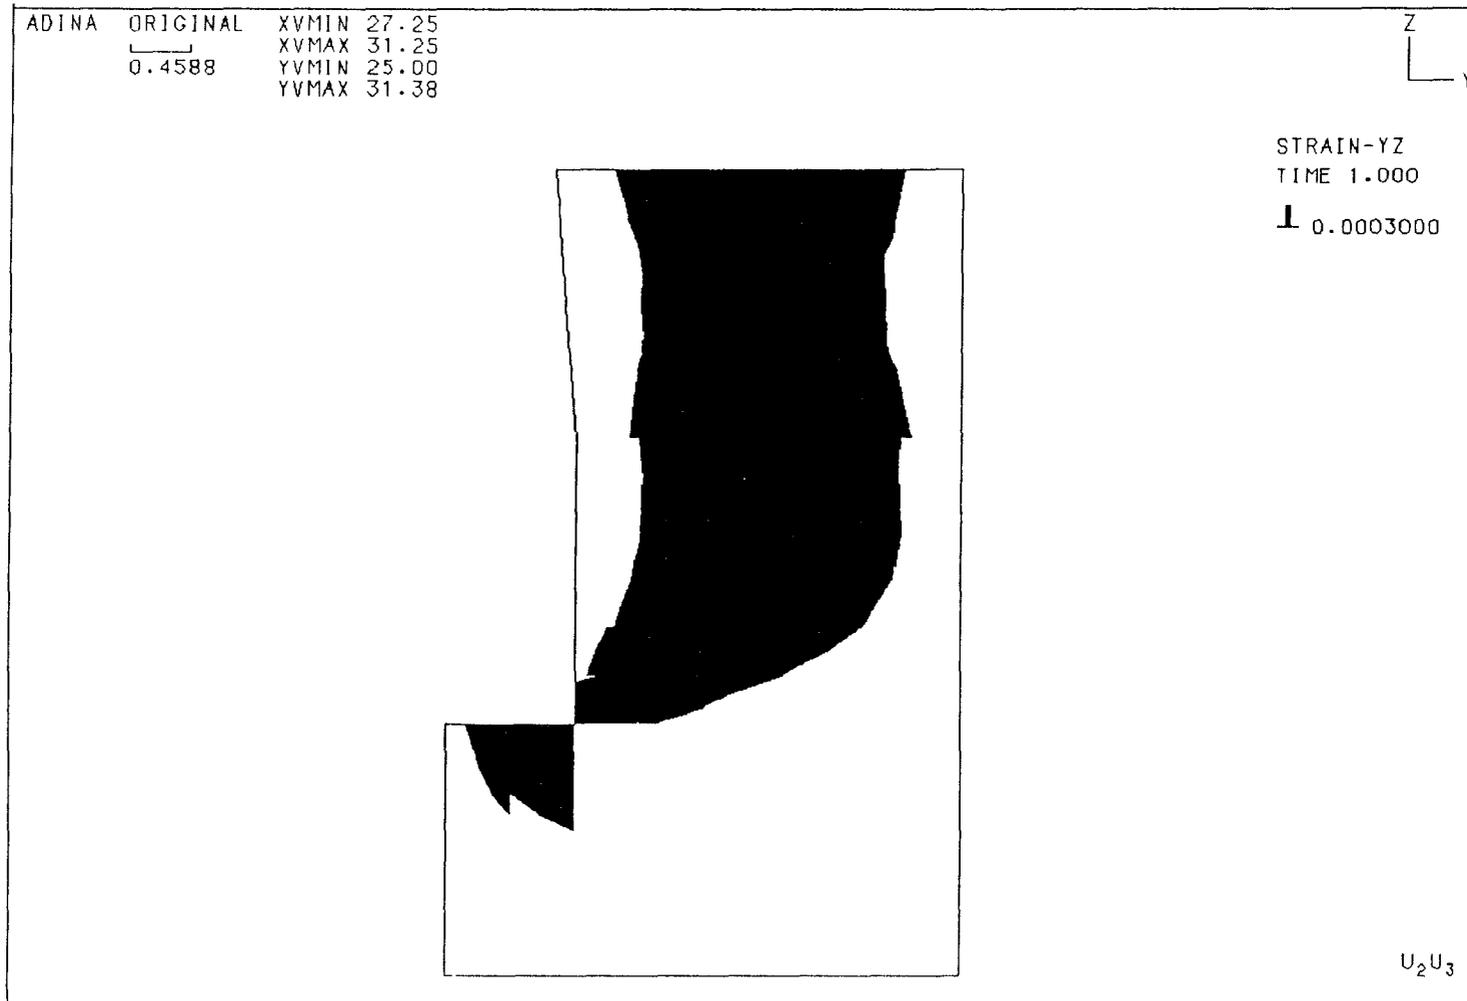
Figure 4.44 Strain Distribution in the Lower Joint

Figure 4.44 shows the strain distribution in the previous joint. Below the shear keys, the upper columns are subjected to strains far exceeded the tensile strain of concrete (0.000124), indicating extensive cracking at these locations.
